# A needle in the haystack

## The search of “Rua Mar” in the limits of a 30 kHz multibeam sonar

LCDR Jose Cordero, LT Luis Rioja, LT Francisco Salazar  
Rover Vessel “Tofiño”, Instituto Hidrográfico de la Marina, Spanish Navy

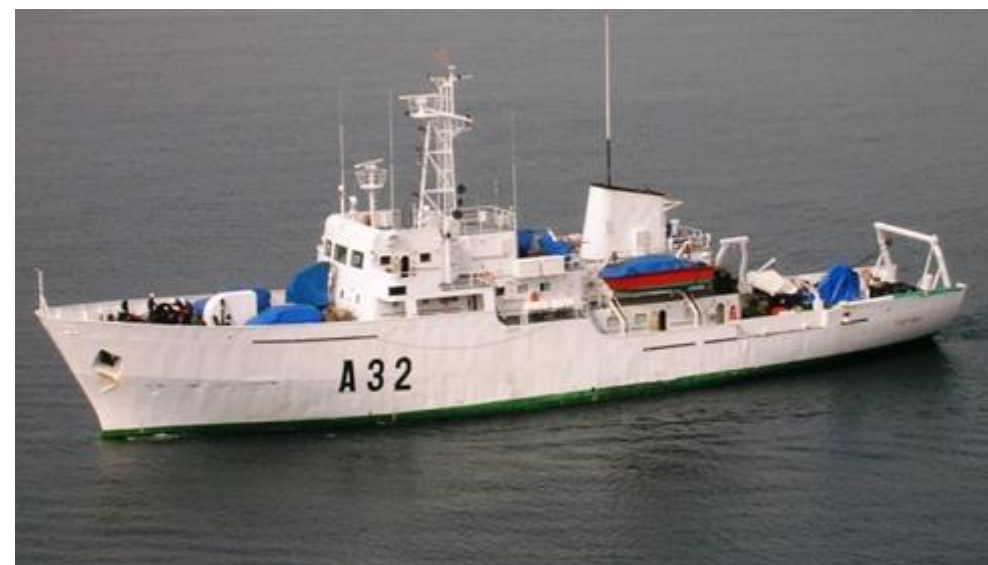
Figure 2. R/V “Tofiño”.

In January 23, 2020, “Rua Mar”, a 15m long fishing boat disappeared during a gale 27 miles off Cape Espartel (Morocco) on a poorly charted seafloor. RV “Tofiño”, fitted with a dated Kongsberg EM-300 (2°x2°) MBES and a Klein 3900 towed side scan sonar, joined the search of Rua Mar by providing an accurate seafloor model and detecting wreck-like features on a 525 km<sup>2</sup> area, comprising depths down to 800 m.

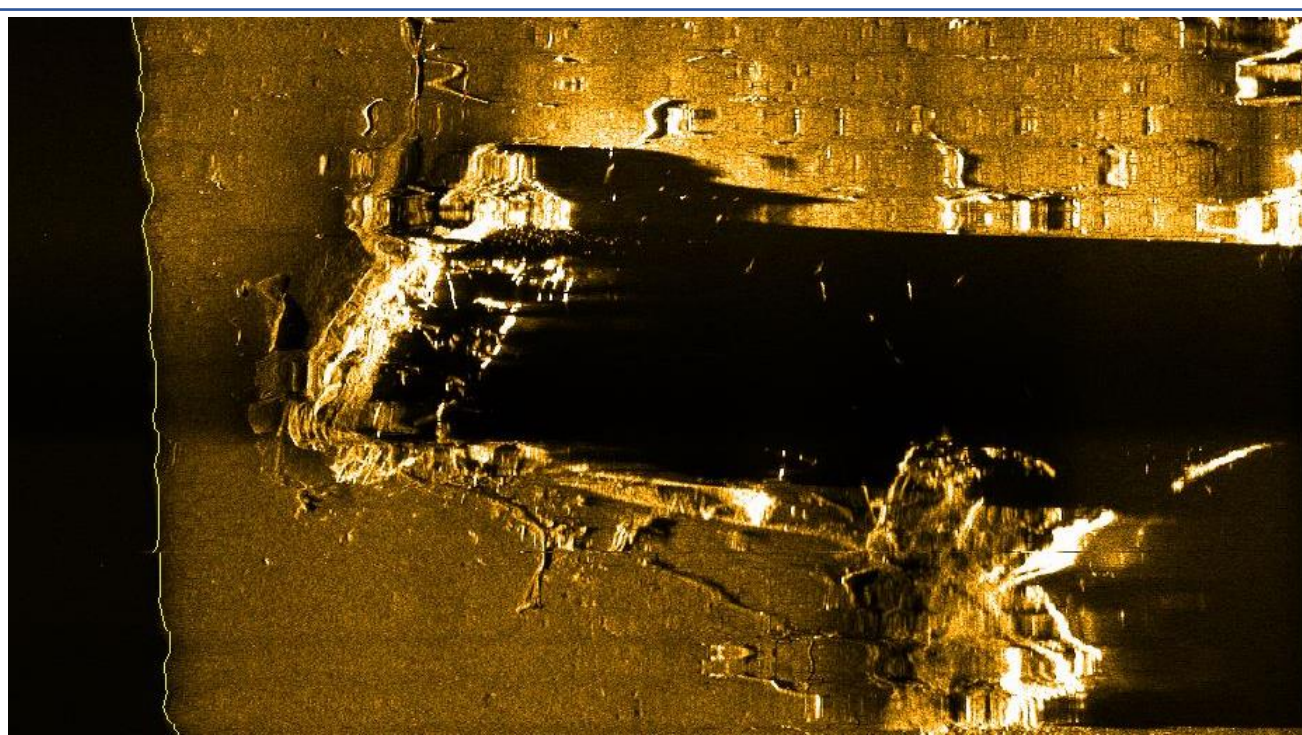
Figure 3. Shipwreck image from the SSS

A Klein 3900 SSS was used to obtain acoustic images of the MBES detections down to 300 m deep.

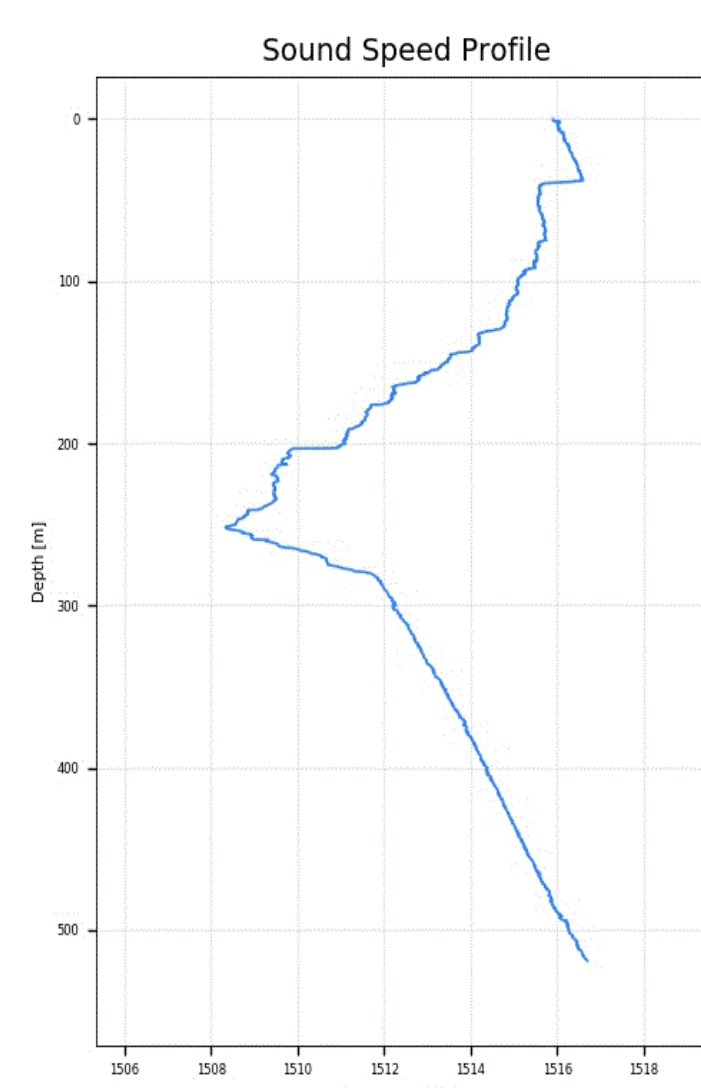
Figure 4. Sound speed profile

Great variability of ocean temperature and density was accounted by frequently profiling the water column
