Analysis of S. João da Caparica beach vulnerability to a maritime storm event

Filipa S. B. F. Oliveira, A. B. Fortunato and Paula M. S. Freire
foliveira@inec.pt
Laboratório Nacional de Engenharia Civil, DHA – NEC, Lisboa

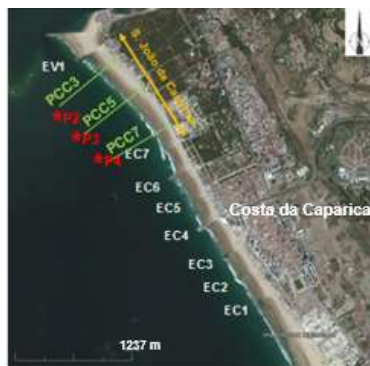
Aerial photograph of S. João da Caparica beach between groyne EV1 and EC7. Location of profiles PCC3, PCC5 and PCC7, used in the calibration of XBeach. Points P2, P3 and P4 of hydrodynamic data (© Google Earth).

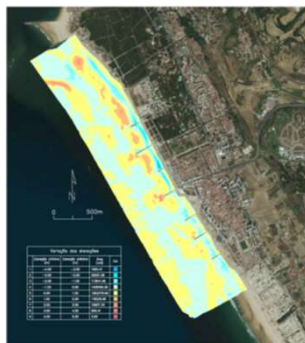
Topo-bathymetric evolution during the calibration period, set-out/2014.

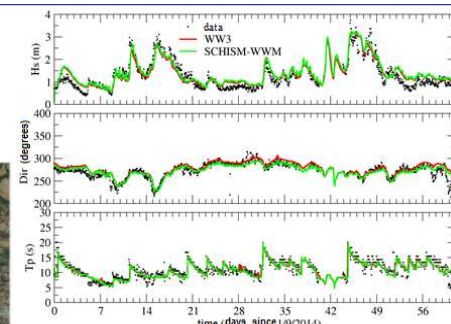
Validation of the wave climate models: hindcast values against buoy data (Hs, above; Dir, middle; and Tp, below).
